Inspection Report

Property Address:
210 Easy Street Dr
San Antonio TX 78260

A 1st Class Home Inspection, PLLC

Date: 2/5/2010	Time: 10:00 AM	Report ID: 10015
Property: 210 Easy Street Dr San Antonio TX 78260	Customer: Gomer Pyle	Real Estate Professional:

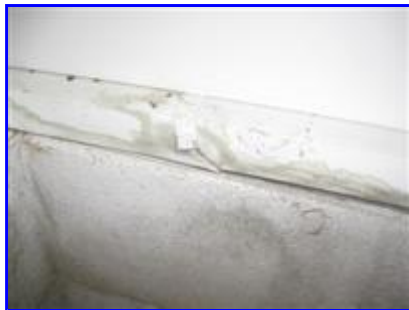
1.0 Picture 1

Slight stains were noted on the bottom plate in the garage due to moisture. I am unable to determine when or how often the staining occurs. I recommend further evaluation if concerns exist by a qualified contractor.

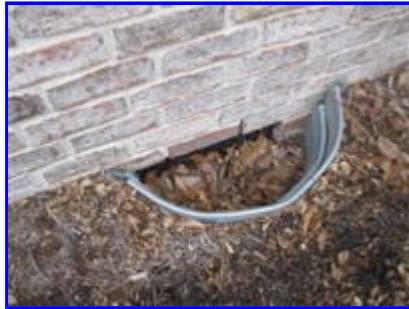
1.2 Picture 1

(2) There is a negative slope towards the rear of home. This area should be continually monitored to insure it drains water away from home after heavy rains.

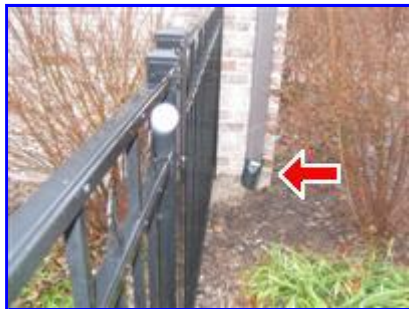
1.3 Picture 1

(1) The downspouts that discharge below grade level should be monitored. If they are ever suspected to be clogged or disconnected below grade, they should be redirected to discharge at least five feet from the building. Foundation leakage adjacent to a downspout is an indication of a problem below grade.

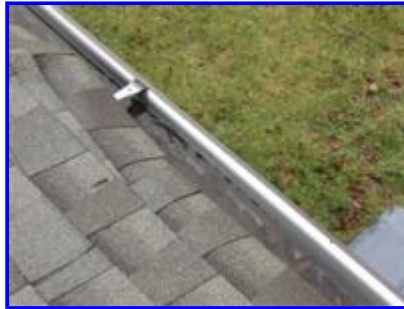
1.3 Picture 2

(2) The roofing required typical maintenance. An application of caulk should be added to all the exposed nail heads and fasteners at the vents, plumbing jacks and flashing. Also, an inspection for nail pops and cracked boot jacks should be addressed annually by a qualified person.

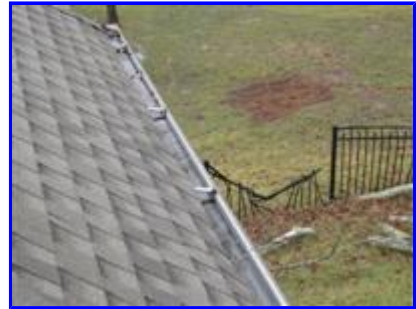
1.3 Picture 3

(3) Gutters are holding water due to leaves or debris (clogged), and should be corrected. Clogged gutters can lead to water intrusion at the home and potential structural damages. Also, these leaves can hide rust and holes that need to be addressed. A thorough cleaning is needed in the spring and fall of each year.

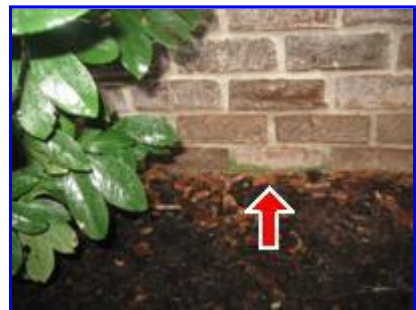
1.5 Picture 2

(2) Slight discoloration was noted on the garage wall behind the storage box. This could be due to trapped moisture at this area. Also, there is evidence of moss growth on the exterior brick veneer siding and front stairs of the home. I recommend cleaning by a qualified person for maintenance.

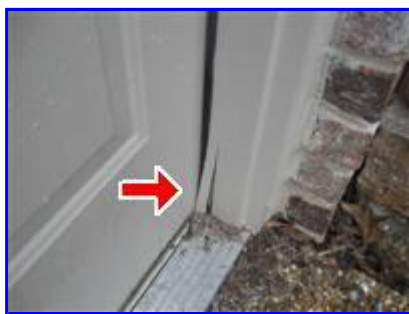
1.6 Picture 1

(1) The bottom of the door jam is cracked at the side entry door to the garage. Although the crack is mostly cosmetic, this area is subject to excessive moisture exposure and should be improved to protect the wood from slight deterioration and to create a more energy efficient seal.

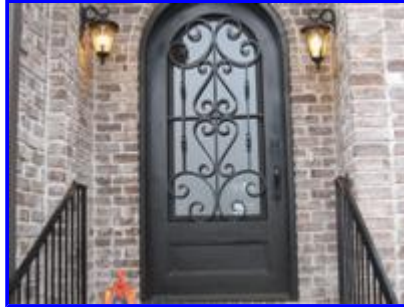
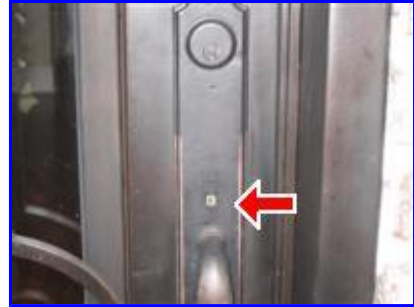
(2) The front door hardware is damaged or missing and needs to be repaired. I recommend further evaluation and repair by a qualified person.

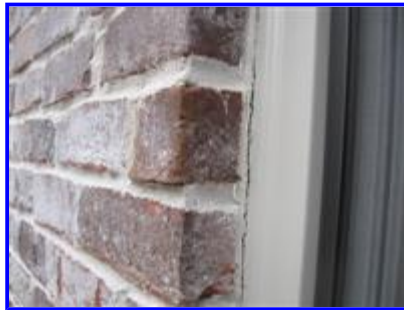
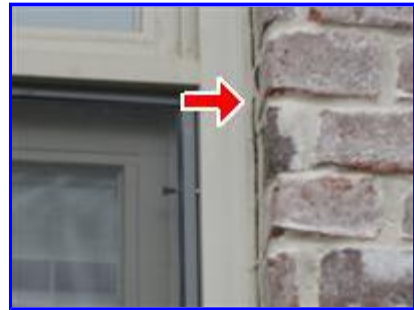
(1) The prior application of caulk and paint is failing in areas and may need to be periodically improved to protect the wood trim around the window's exterior trim and casing and at the interior trim and sill to create a more energy efficient seal. Excess moisture or condensation could be the cause of interior drywall damage and potential structural damages. Periodic maintenance improvements are recommended.

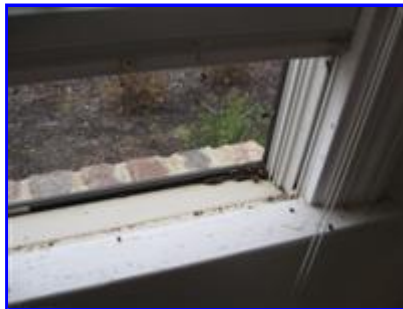
1.7 Picture 3

(2) Several of the window frames are dirty and need to be cleaned. The weep holes that let moisture drain out from the frames are clogged. If improvements are not made, it is possible for framing and interior damages to occur. Preventive maintenance is needed.

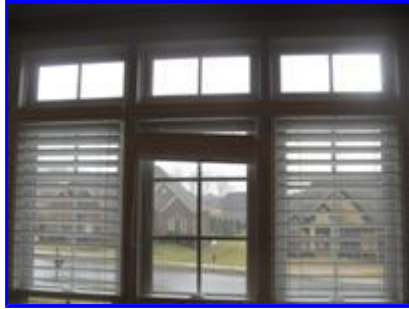
1.7 Picture 4

(3) Several strips of weather-tape have fallen from the windows' top sash in the office and downstairs jack/ jill bathroom. This could be due to improper securing at the time of installation or expansion and contraction. I recommend further evaluation and repair by a qualified person.

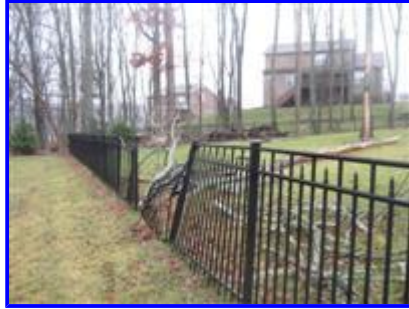
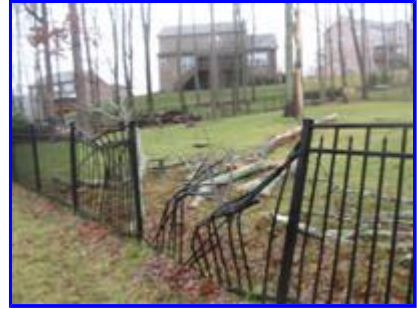
🔧 A tree has fallen on a left run section of the fence at the rear of the home. The fence is damaged. This should be further evaluated and repaired by a qualified contractor.

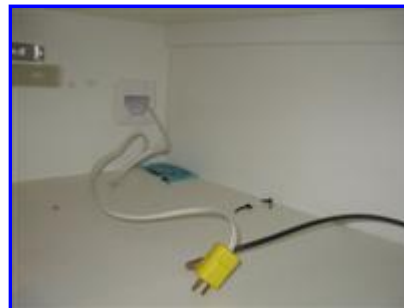
2.1 Picture 1

(1) The outlet over the fireplace intended for a suspended flat screen tv is not properly hard wired. An extension cord is not an approved permanent wiring type. I recommend further evaluation and improvements after further evaluation by a qualified electrician. Safety concerns exist until this wiring configuration is approved by a professional.

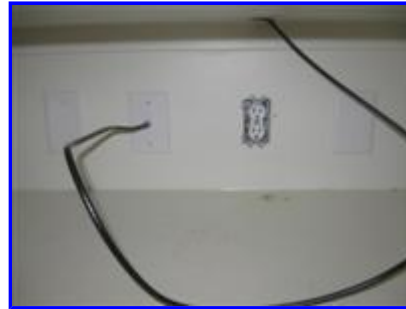
2.1 Picture 2

+ (2) A cover for the electrical outlet in the living room cabinetry is missing. A replacement cover is recommended for safety.

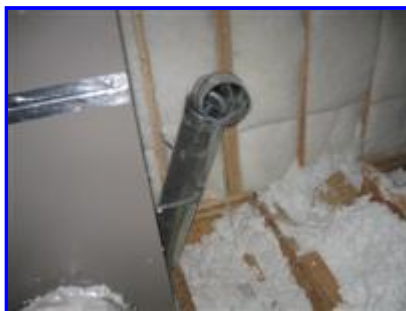
5.2 Picture 1

(1) The range hood fan vents into the attic space and should vent to the outside. Also, the unit rattles when operated. This would require a vent hood and kit and further evaluation of the rattling. I recommend repair or replace as needed.

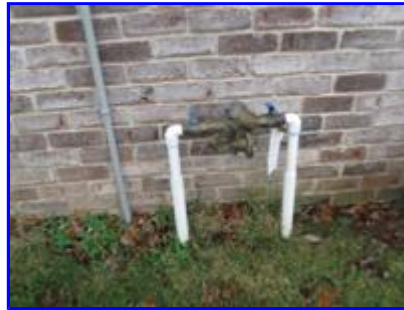
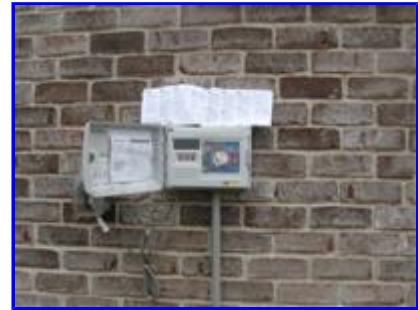
The lawn sprinklers were off and could not be inspected. I recommend full evaluation after turning on the water in warmer temperatures.
