## Inspection Report

Sample Report - 1st St. Class Home Inspection Rd.  
San Antonio TX

## PROPERTY INSPECTION REPORT

John McPherson 9732 / A 1st Class Home Inspection, LLC 3/18/2011

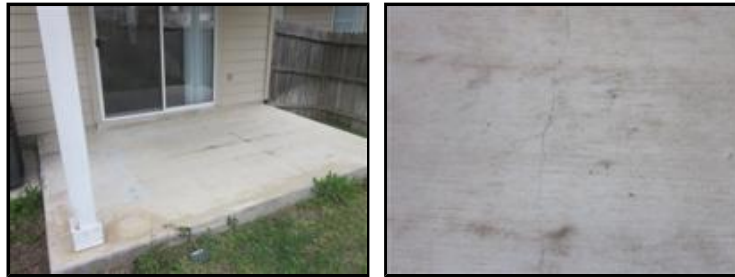
1.0 Foundations

The back porch contains small cracks that are typically associated with shrinkage. These cracks do not appear to be a need for concern at this time. And there were no cracks found around the home's slab foundation. The home's foundation appears to be functioning as intended and there are no foreseen repairs at this time.

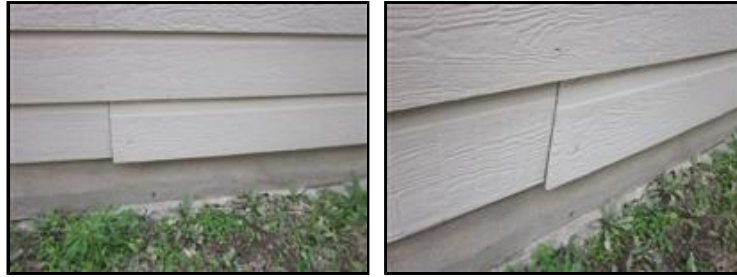
(1) The exterior hardy board siding is coming loose in areas around the home. One or more pieces of siding have lost nails and are hanging loose on the right elevation and several other nails on the left and rear elevation are popping or rusting. The nail pops can eventually lead improperly supported siding and damage to the structure. Re-securing the siding is necessary and should be performed by a qualified contractor to protect the walls from potential moisture intrusion and damage.

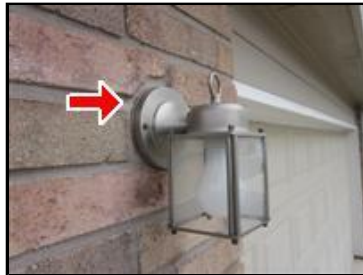
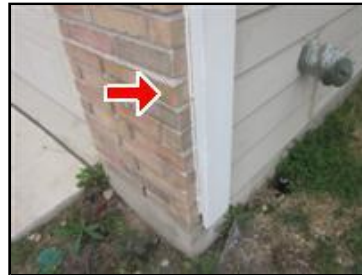
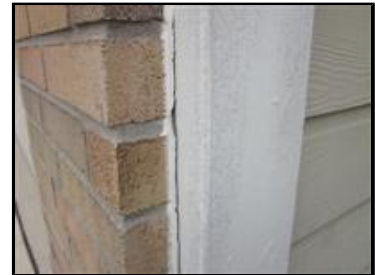
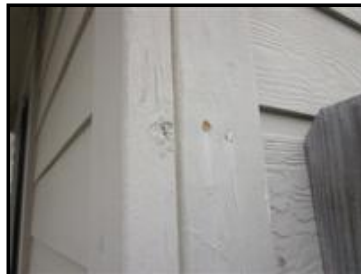
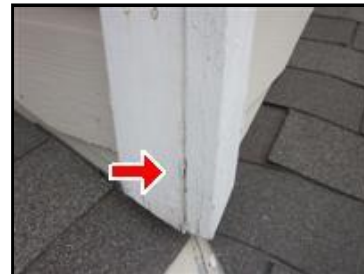
(2) The prior application of caulk and paint is failing or has not been properly applied in areas and may need to be improved to protect the home from moisture intrusion and energy loss in the following areas:

1. Wood trim around the window's exterior trim and casing and at the interior trim and sill to create a more energy efficient seal. Excess moisture or condensation could be the cause of interior drywall damage and potential structural damages. Periodic maintenance improvements are recommended.
2. Caulk at the corner boards that run vertical and protect the edges of the siding from exposure. Improvements are needed on the first and second level of the home.
3. Apply caulk at the base of the exterior light fixtures.
4. Apply caulk to holes in the wall or where service and pipe extensions exit to the exterior.

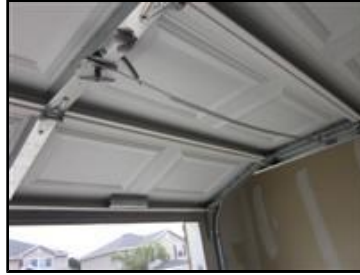
The garage door lock hardware is still installed. This should have been removed when the garage automatic door opener was installed. Improvements are needed to help prevent damage to the doors and rails should it be locked while the door opener is operating. Improvements are recommended at the owner's earliest convenience by a qualified person.

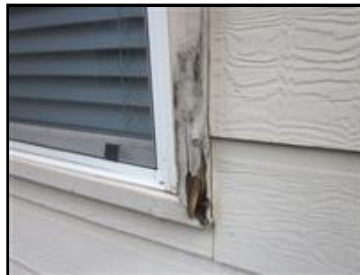
(1) Dry rot was noted around the window trim at the right and left elevations of the home at two or three separate windows. A majority of the dry rot was noted at the window trim around a window on the left elevation. This rot is likely caused by over exposure to moisture due to sprinklers or lack of sun exposure. The rot around the window should be repaired to avoid potential water intrusion that can damage the frame and interior drywall around the window. Repairs should be made as soon as possible by a qualified contractor to prevent further damages.

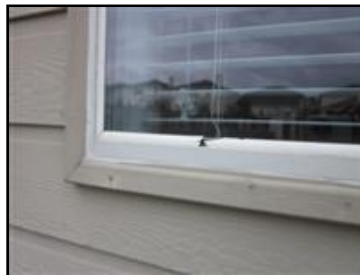
(2) One of the windows at the rear of the home contained a damaged bead. This can sometimes allow sun exposure at the window seal and is also cosmetic damage. I recommend further evaluation and repair by a qualified person.

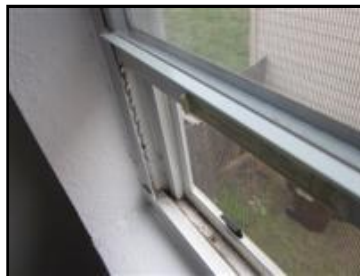
(3) The upstairs loft window rod is bent and the spring rod at the sash is detached. A damaged spring rod will prevent the window from staying open without a prop. Further evaluation and repair is needed by a qualified professional.

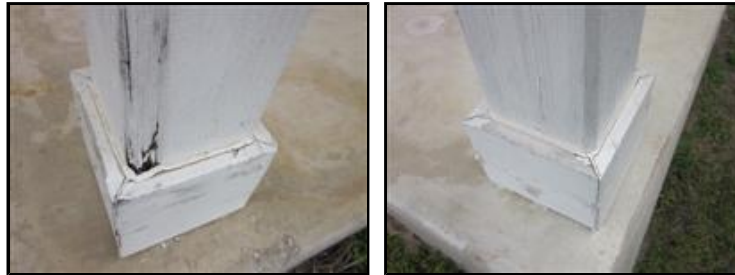
The back porch columns were showing signs of dry rot and deterioration due to high levels of moisture exposure and a lack of proper maintenance. I recommend repairs and proper weather proofing be applied by a qualified person to protect the posts from further dry rot which tends to be more susceptible to pest infestation.

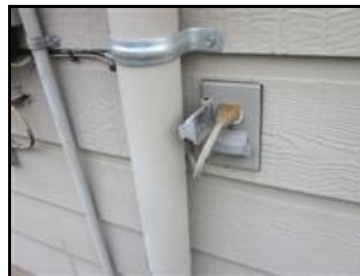
- (1) An electrical extension cord is being used as permanent wiring on the exterior left elevation of the home. This is not allowed. This cord contains excessive sun damage and poses an electrical safety concern. A repair to the current configuration is needed for safety.
- (2) The exterior outlet on the left elevation of the home does not trip to a GFCI test and does not contain the proper weather protective outlet cover. Safety concerns exist until further evaluated and repaired by a qualified electrician.

(1) An electrical extension cord is being used as permanent wiring on the exterior left elevation of the home. This is not allowed. This cord contains excessive sun damage and poses an electrical safety concern. A repair to the current configuration is needed for safety.

(2) The exterior outlet on the left elevation of the home does not trip to a GFCI test and does not contain the proper weather protective outlet cover. Safety concerns exist until further evaluated and repaired by a qualified electrician.

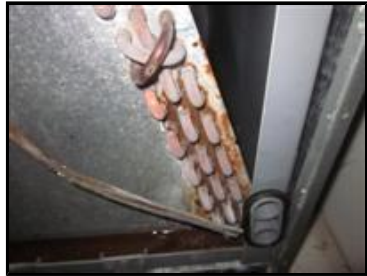
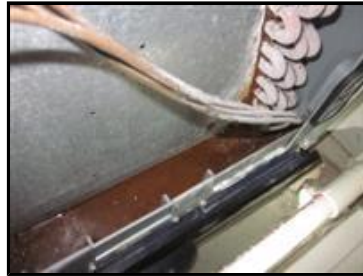
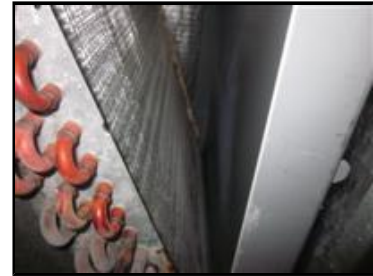
(2) The indoor coils at the electrical furnace were frozen and there was an excessive amount of condensation at the base of the unit and rust buildup around the coils. The rust at the compressor coils appears to be an ongoing issue and a concern. This could be the reason for an inadequate temperature drop when tested in cool mode. A more thorough inspection by a qualified HVAC contractor is needed. Repairs are needed to prevent condensation and future rust development.

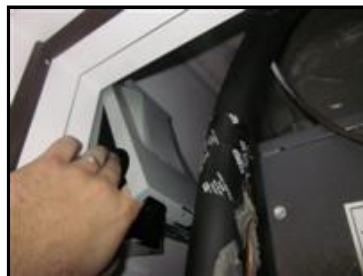
(3) The service disconnect panel was obstructed by the heat pump suction and compression lines in the heat pump closet upstairs. This is not up to today's building requirements and makes maintenance and inspection difficult and a safety concern. I recommend improvements be made by a qualified HVAC technician or electrician at the owner's earliest convenience.

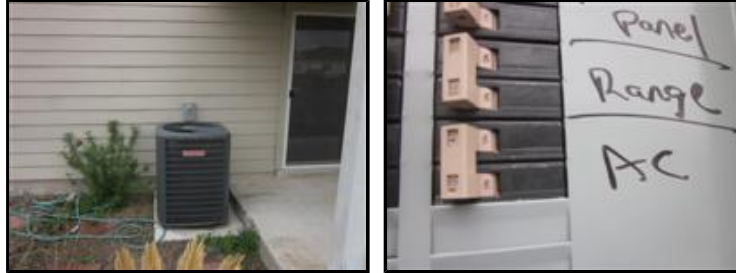
(2) The breaker for the HVAC system(s) is over the max amperage size as recommended by the current HVAC system service label. Oversized breakers can result in overheating, arcing, and possibly other premature defects requiring maintenance repairs. It is recommended that an HVAC specialist re-evaluate the wires and current breakers and make changes as needed.

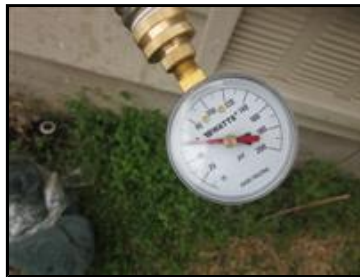
There was 60psi of pressure on the water lines when tested at the exterior of the home. This is considered to be on the safe side. 80lbs of pressure is the maximum allowed.

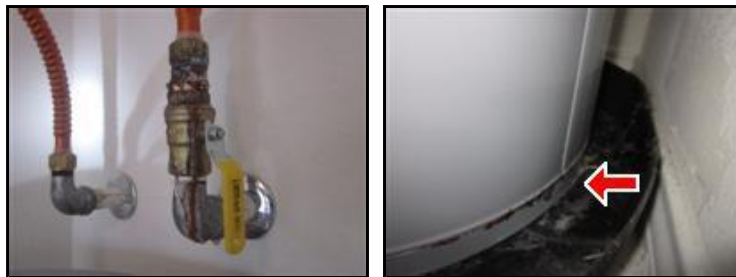
The water heater appears to be leaking at the cold supply inlet. Leaks can cause damage to unit or home and can shorten its life span of the unit. A slight amount of rust is noted around the water heater cover and at the base of the unit from this ongoing leak. The rust does not appear to have caused much damage at this time. A qualified licensed plumber should repair or correct as needed.

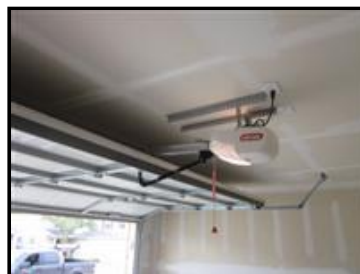
5.7 **Garage Door Operator(s) - Comments:**

The track for the garage door opener is not level and additional wear or stress on the track and motor can eventually occur. Also, the door motor was somewhat louder when operated. I was unable to determine if the slanted track rail was the reason for the louder motor. Furthermore, I am unable to determine if repairs are needed. I recommend further evaluation by a qualified person if concerns exist.
